Habitat Restoration Feasibility Study at the Robinson Duck Farm County Park

Project:
 ROBINSON DUCK FARM
 COUNTY PARK
 HABITAT RESTORATION
 FEASIBILITY STUDY

Task 2 – Identify Recognized Environmental Conditions

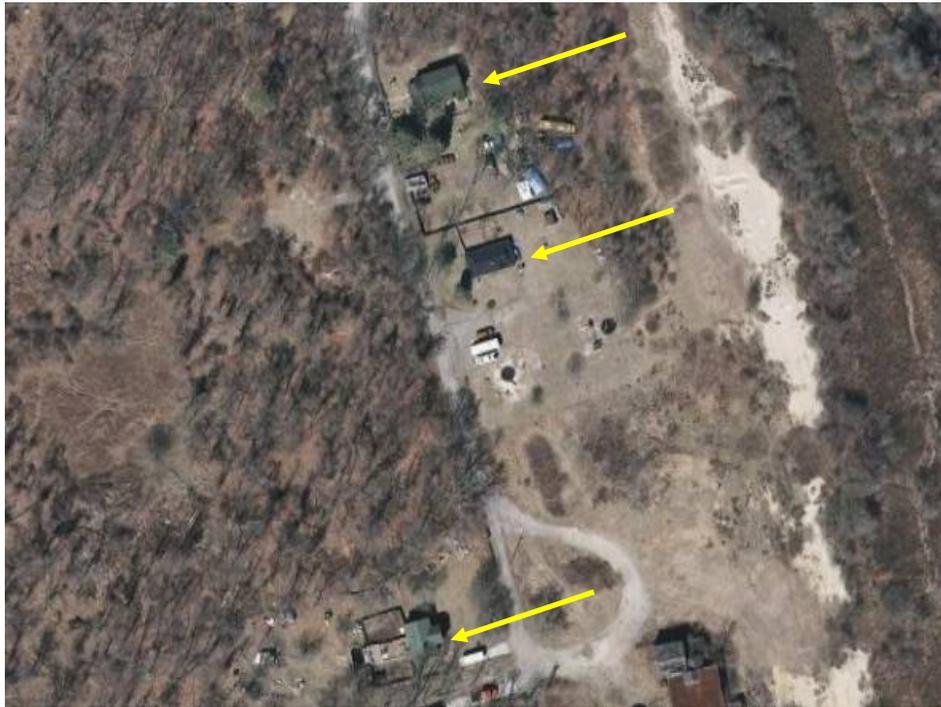
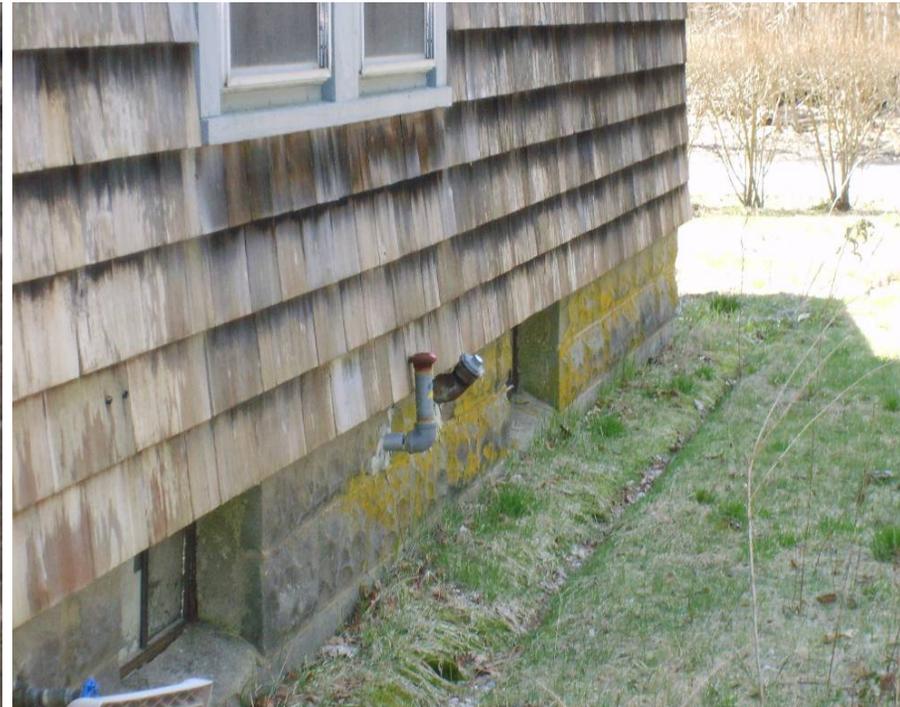
Location of the three residential homes. Only the central one is currently occupied.

View of fuel oil tank fill and vent, typical of each of the three homes.

- Fuel oil tanks present in the basement of each building. PWGC recommends inspecting each of the tank areas for signs of leaks/spills.

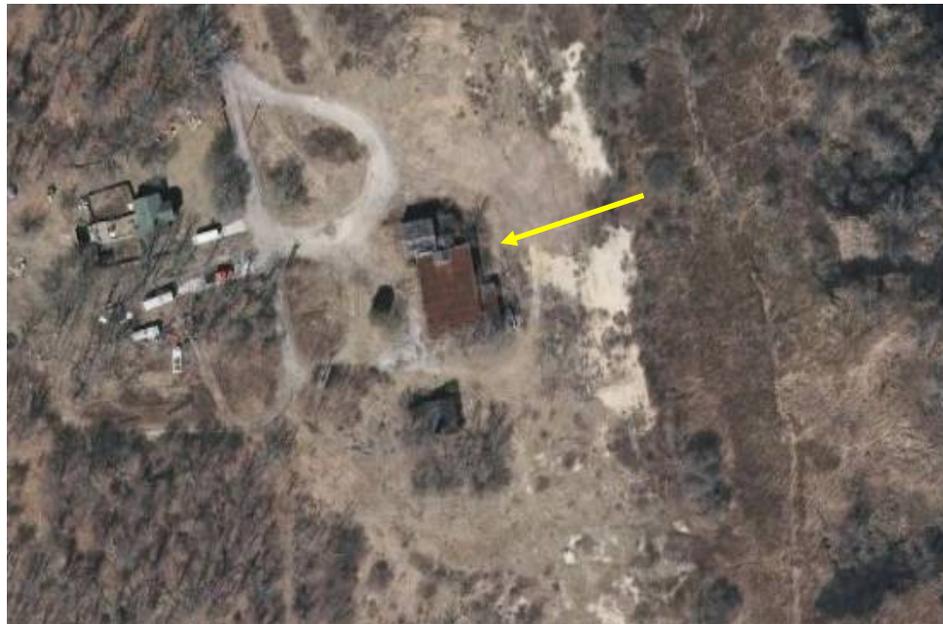
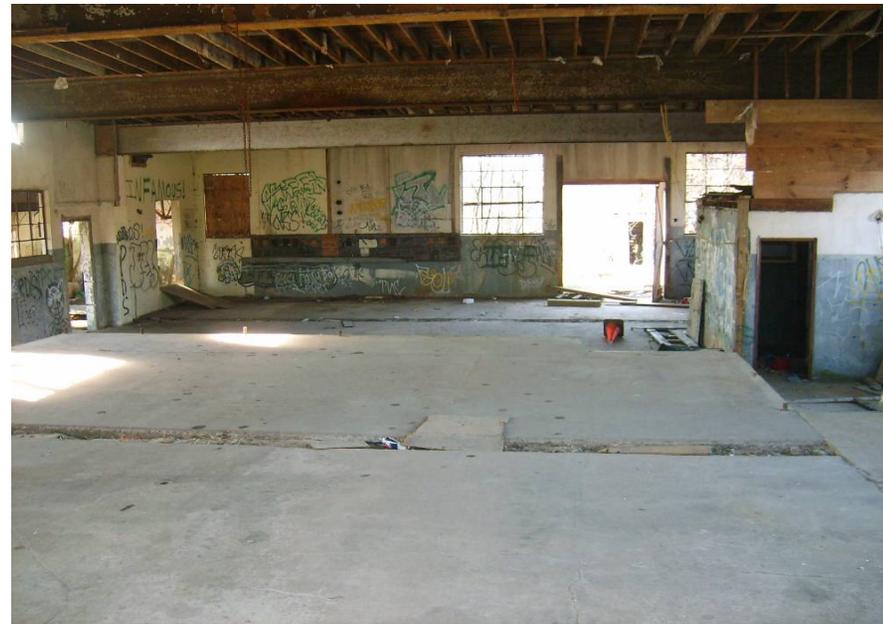
Location of northern farm building

Interior view of northern farm building showing trench drains which appear to have discharged to the east.

- Onsite sanitary system associated with this building. PWGC recommends that the sanitary system and floordrain discharge locations be exposed with a backhoe.

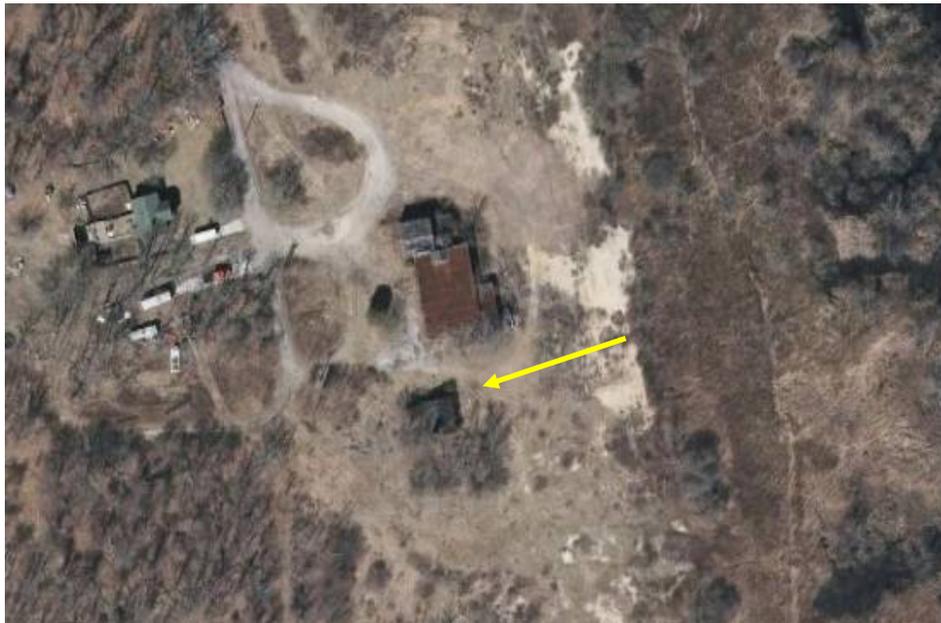
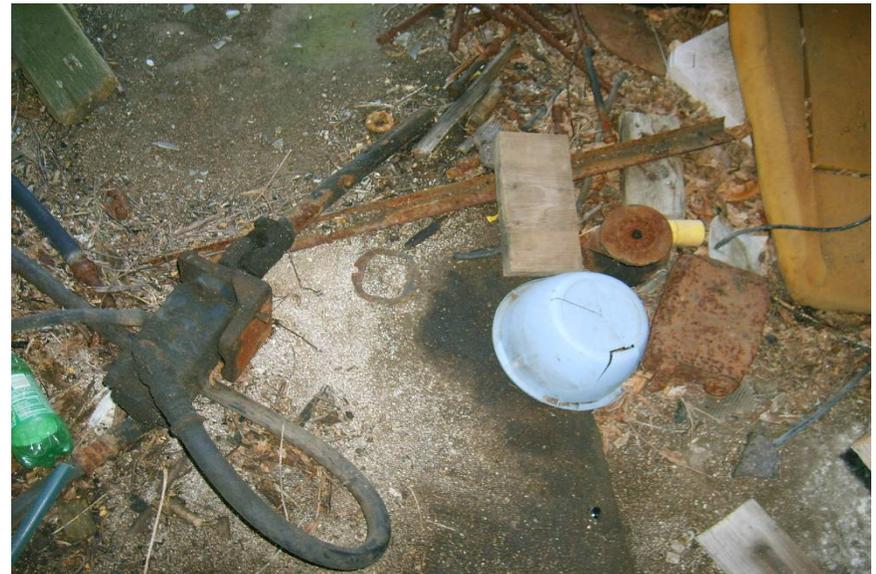
Location of the southern farm building

View of automotive parts and oil staining present within the southern farm building.

- Building used as repair shop. PWGC recommends hand excavating the areas of potential soil staining in order to determine if the staining is superficial or indicative of a notable spill.

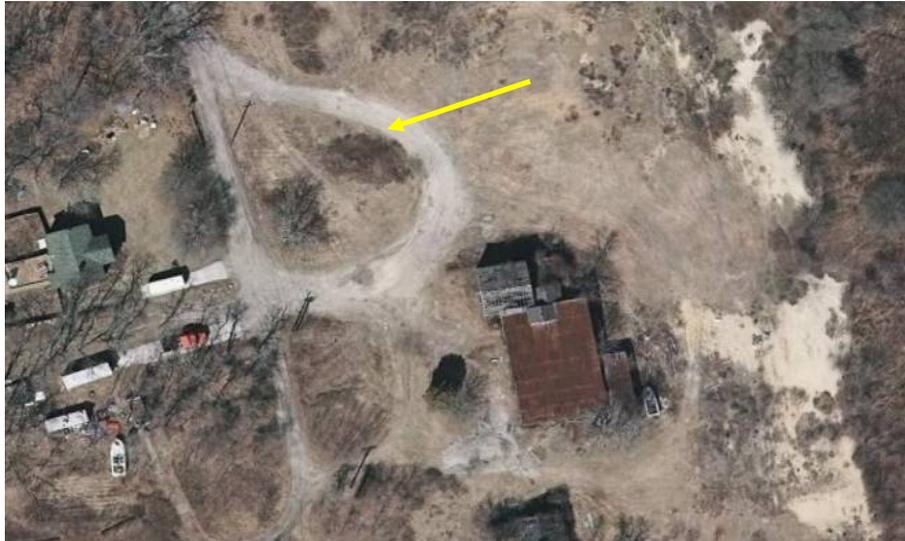
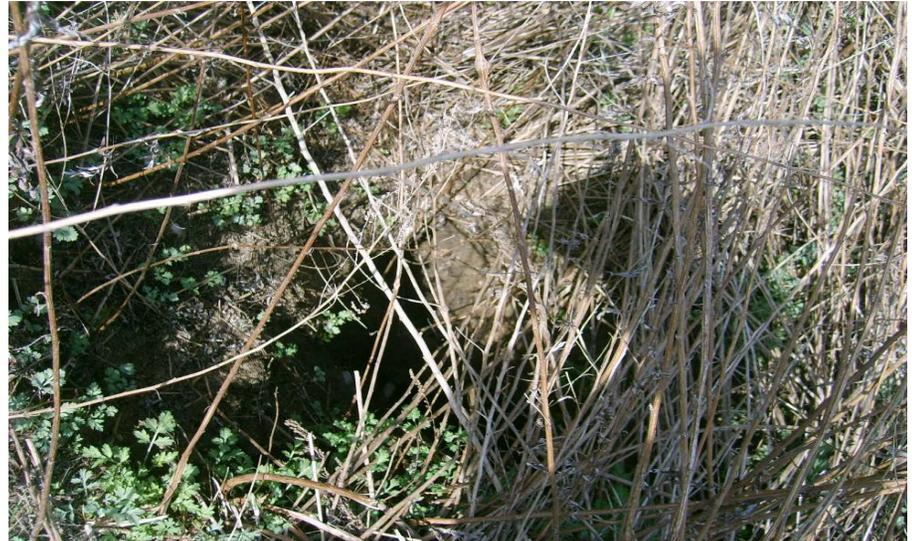
Location of suspected collapsing leaching structures located northwest of the northern farm building.

View of one of the collapsing structure which is causing a large sinkhole to form.

- PWGC recommends that the structures be exposed so that a sample can be collected from the base of each structure for as per SCDHS prior to closure.

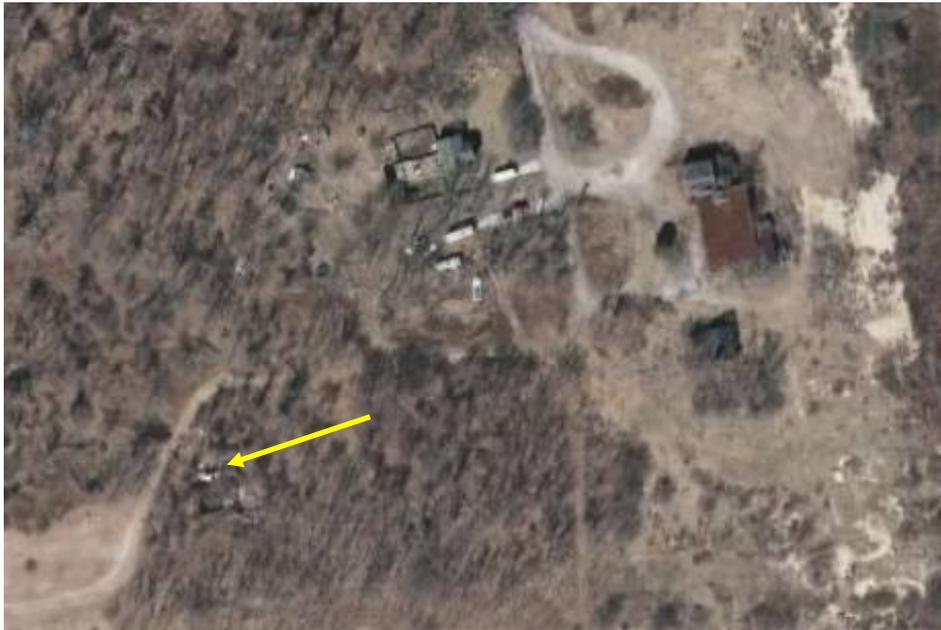
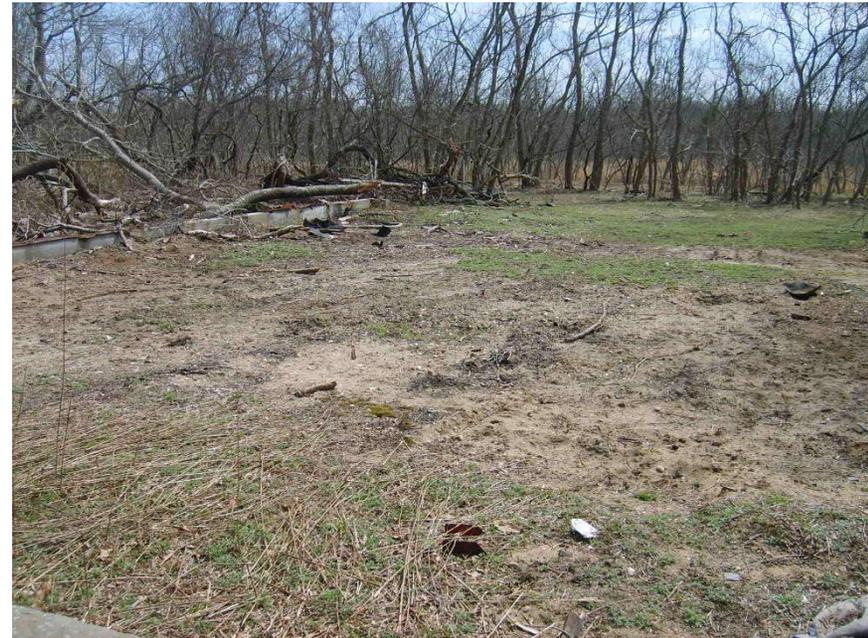
- Building has been demolished. No impact noted, PWGC does not recommend any sampling of the former hangar area at this time.

Location of the former aircraft hanger (aerial photo taken prior to demolition of the building).

View of the former aircraft hanger area following removal of the building.

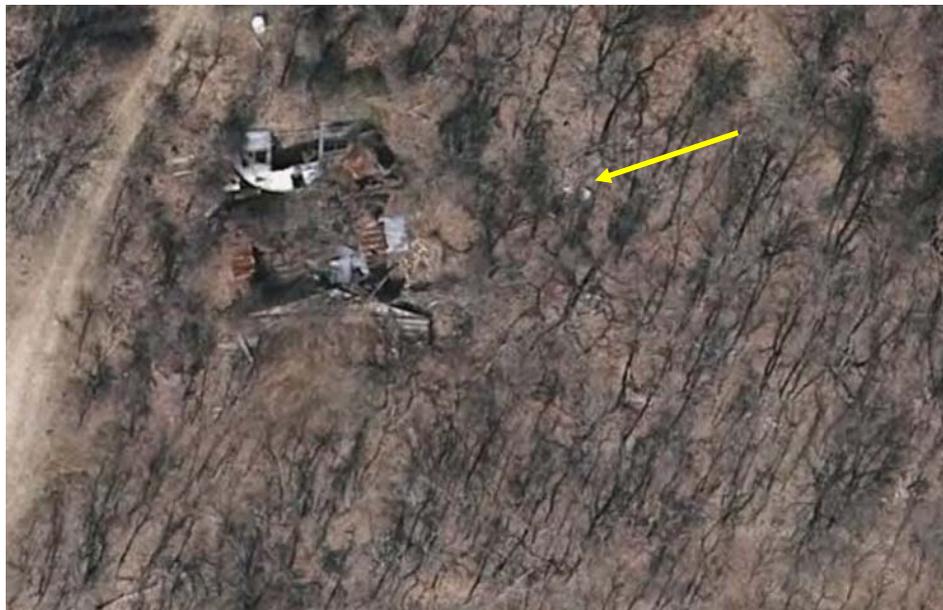
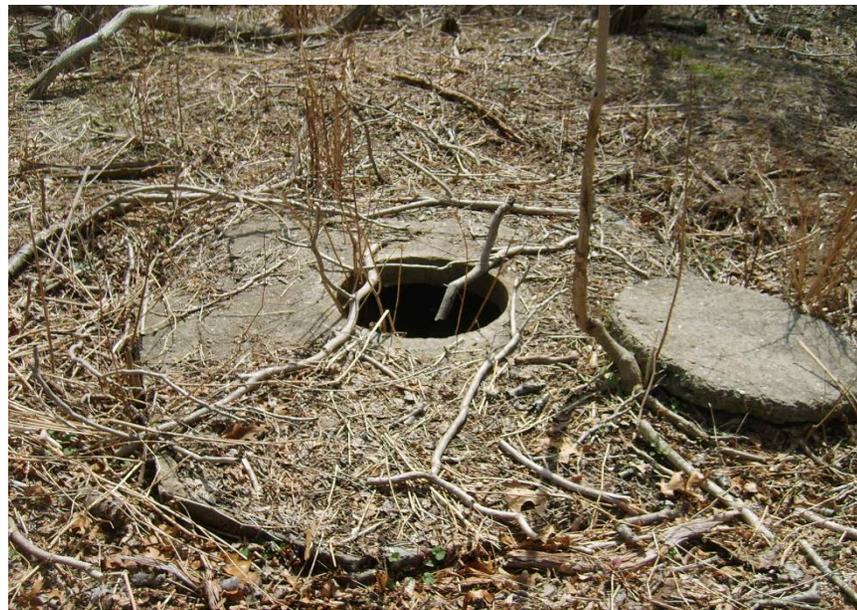
Location of the leaching pools identified east of the former hangar building.

View of one of the two identified leaching pools located east of the former hangar. The other structure was of similar construction.

- PWGC recommends performing soil borings through both structures to identify the former base of the structure.

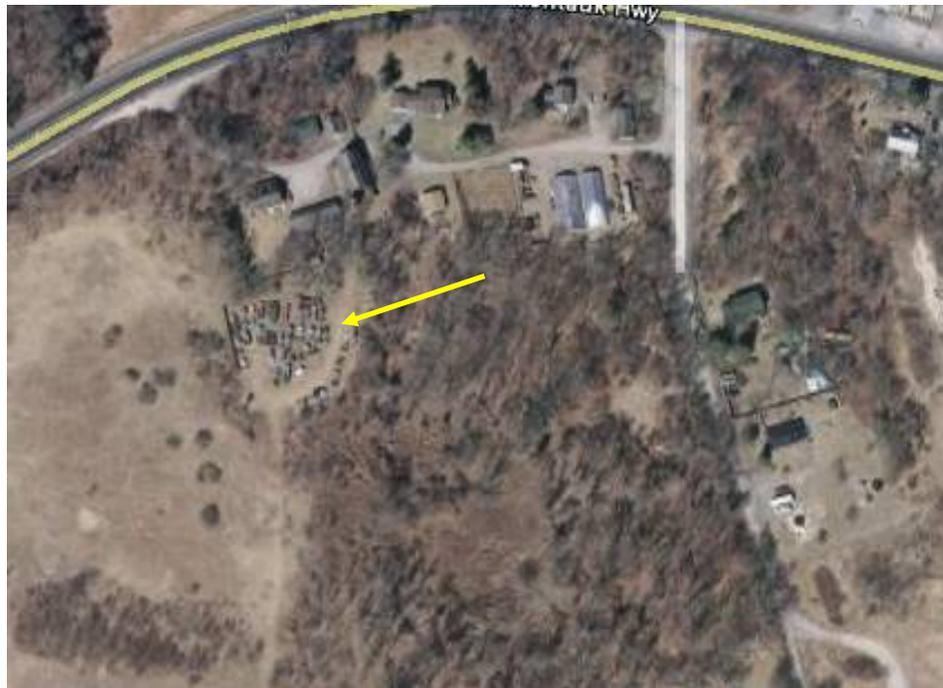
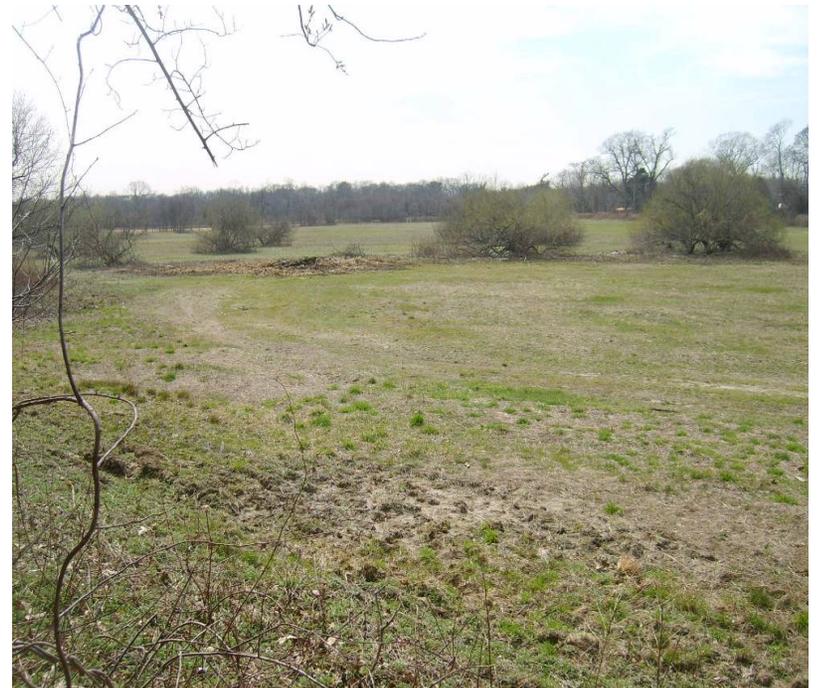
- Vehicles have been removed. No staining was noted. PWGC does not recommend any sampling of the former vehicle storage area at this time.

Location of the former vehicle storage area. Vehicles have since been removed.

View of the former vehicle storage area. No signs of impact or soil staining were noted.

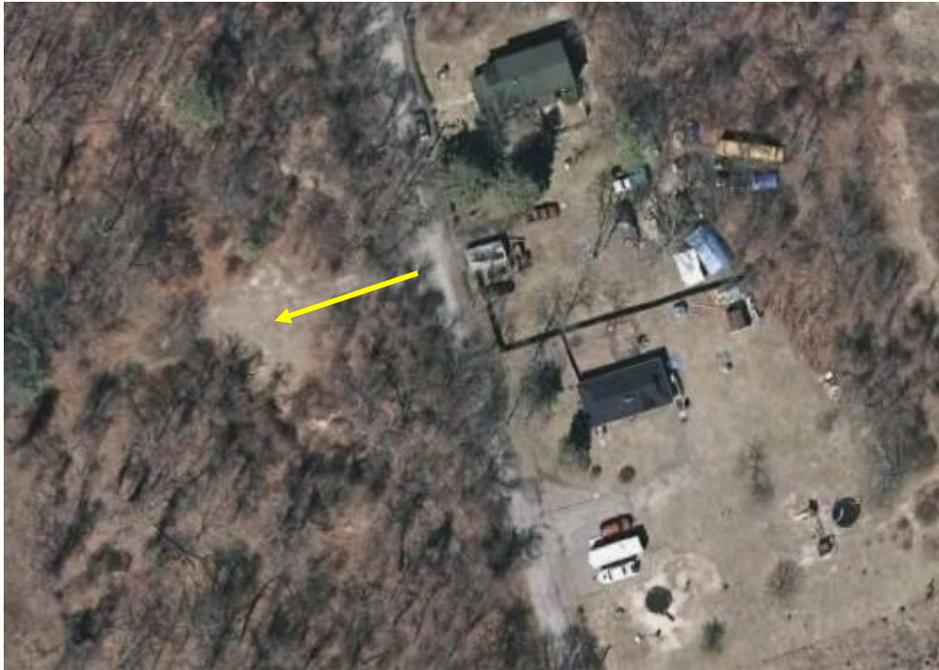
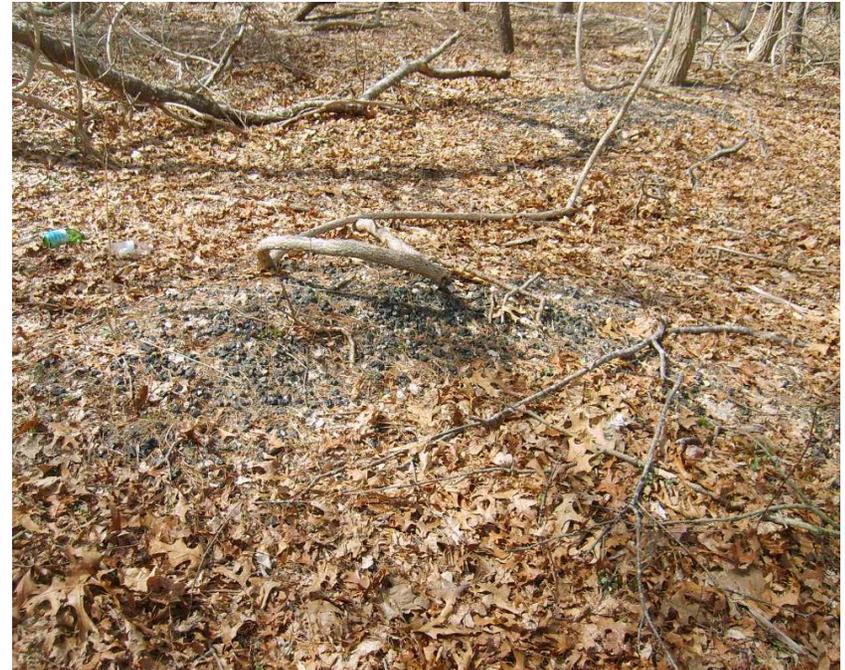
Location of former coal storage area.

View of coal piles observed in an apparent former coal storage area.

- A former coal storage area was observed. PWGC recommends that the coal and shallow surface soils be removed and properly disposed of.

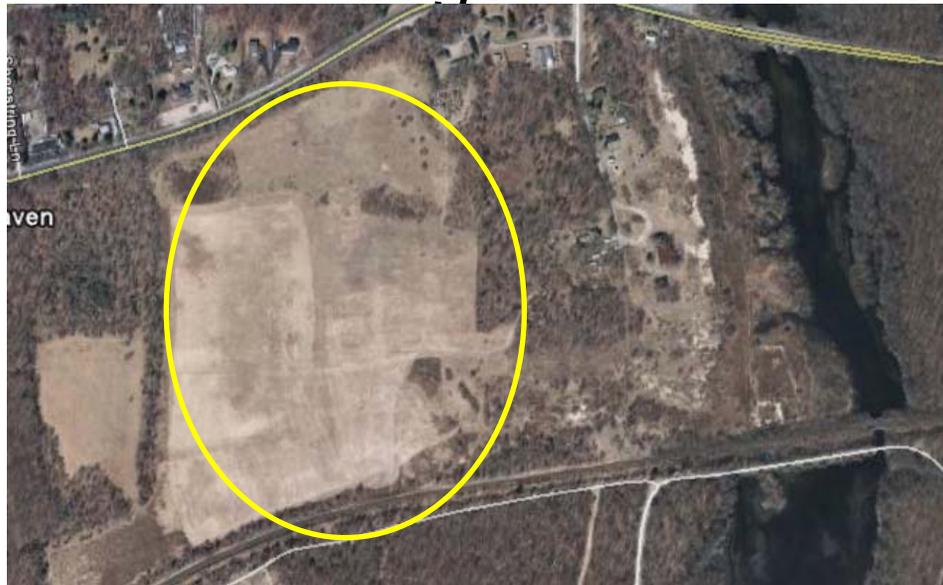
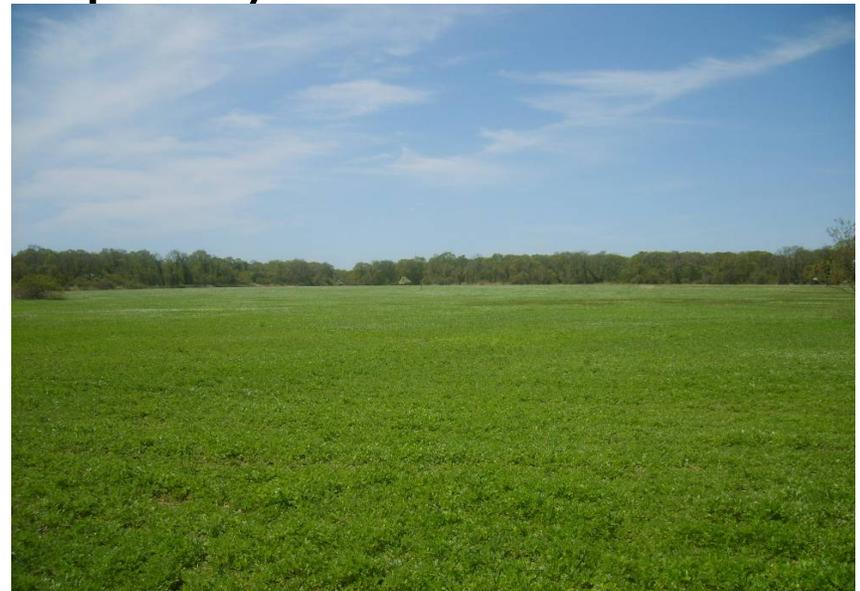
Location of former agricultural fields

View of the former agricultural fields (summer 2008 photo)

- Pesticides may have been used in the field and duck waste may have been used as a fertilizer. PWGC recommends conducting representative soil borings to two feet below grade utilizing a hand auger to assess soil quality.

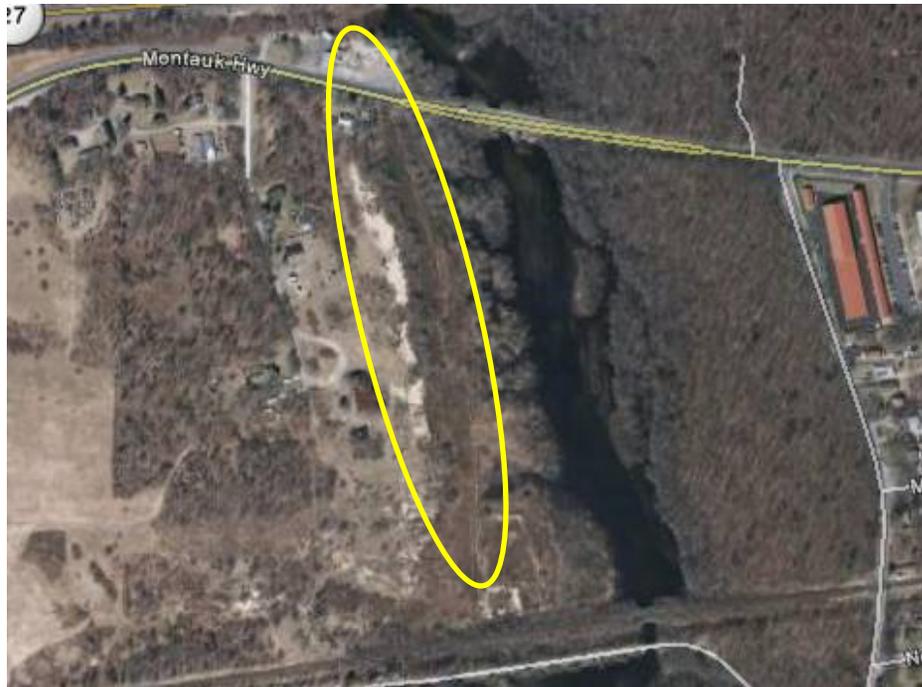
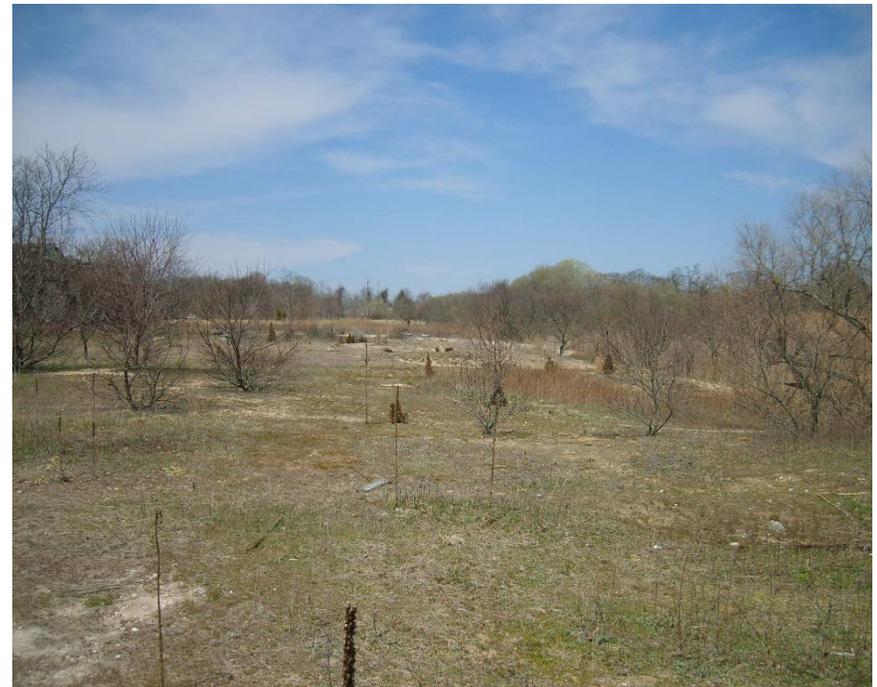
Location of the former swim ponds and waste lagoon (south end)

View of the former swim pond area looking northward.

- PWGC recommends that several representative soil borings be performed to assess the vertical extent of duck waste.

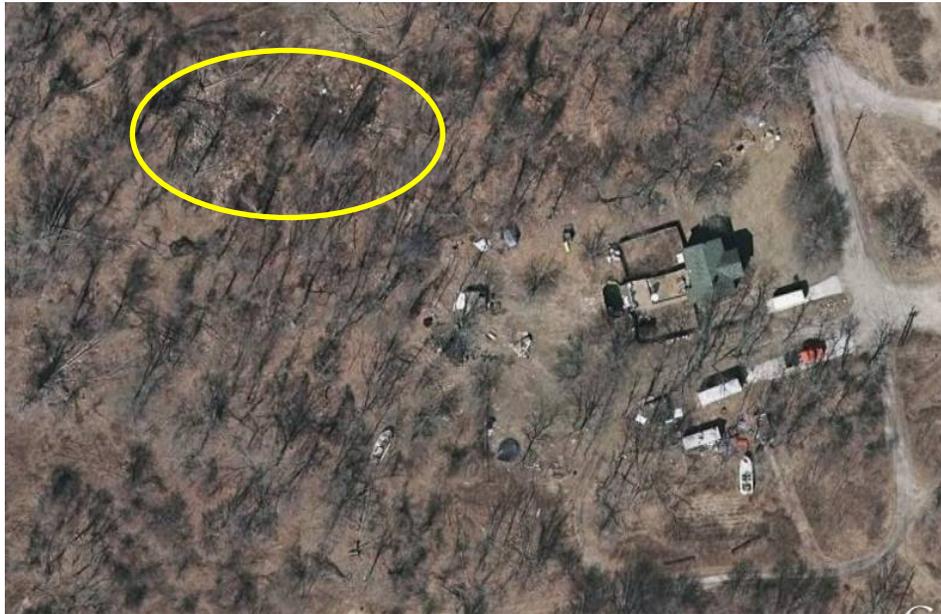
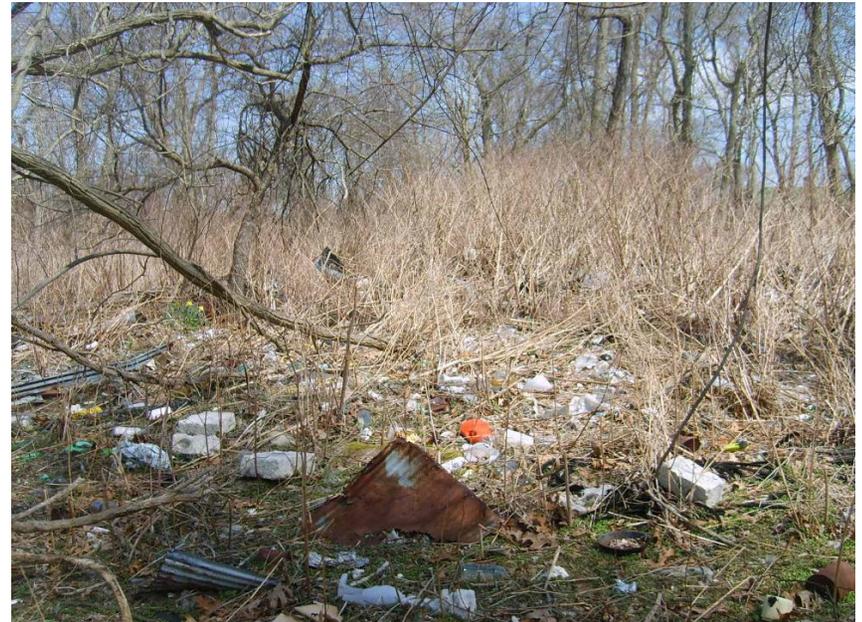
Location of the debris / trash dumping area.

View of the western portion of the debris / trash dumping area

- A former dumping area was identified. PWGC recommends that the debris be removed and properly disposed of. During removal, the area should be assessed for potential impacts.
