#### **4. Surface and Subsurface Environmental Conditions**

Phase 1 Environmental Site Assessments were prepared for the project site by ERM and are provided in Appendix C, and summarized below.

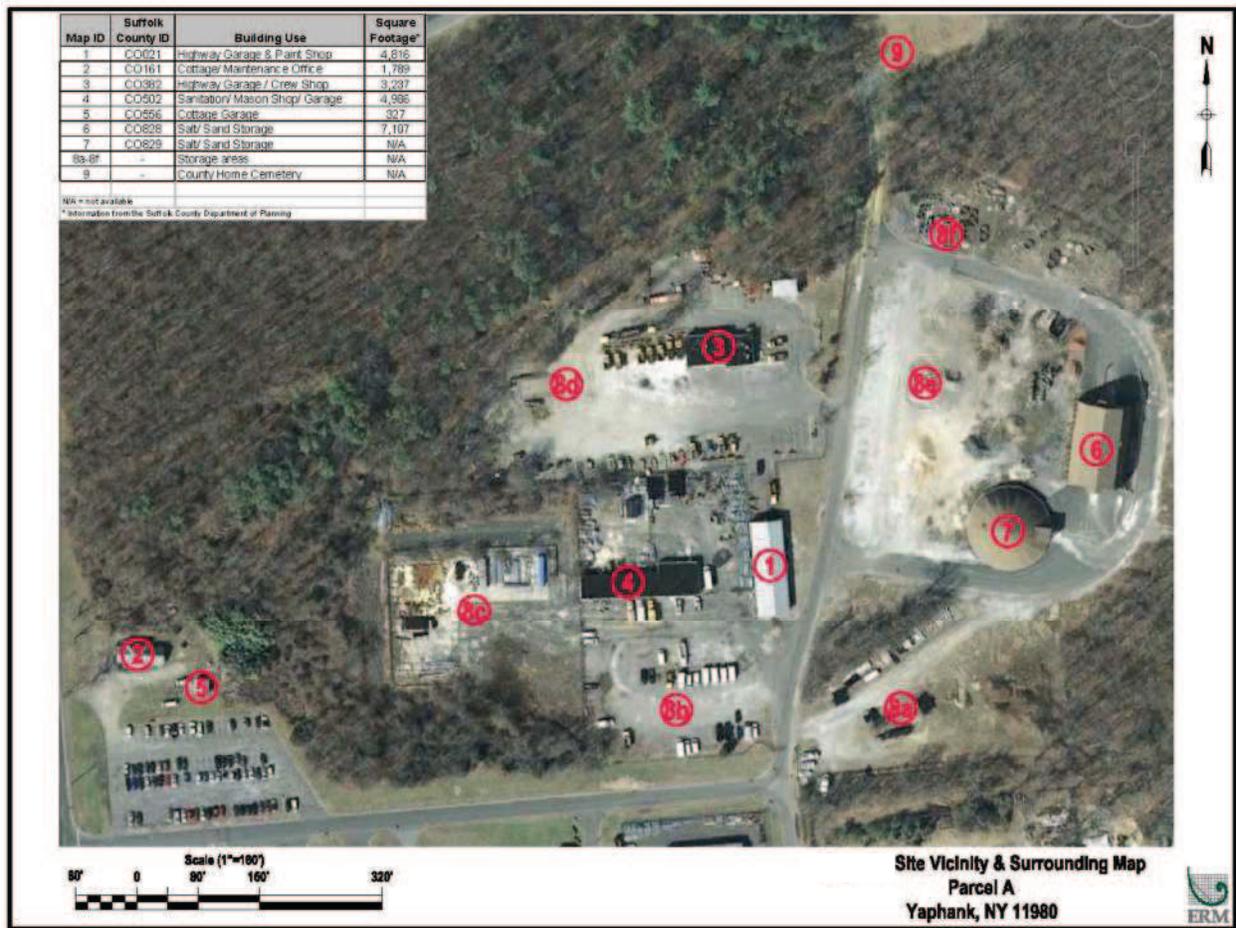
Area A is a ±34 acre irregular shaped Area of land located in the Town of Brookhaven, New York, approximately 200 feet south of the Long Island Expressway (Interstate-495) and adjacent to Yaphank Avenue (County Road 21). The general location of Area A and surrounding area physiographic features are shown on Figure 4-1.

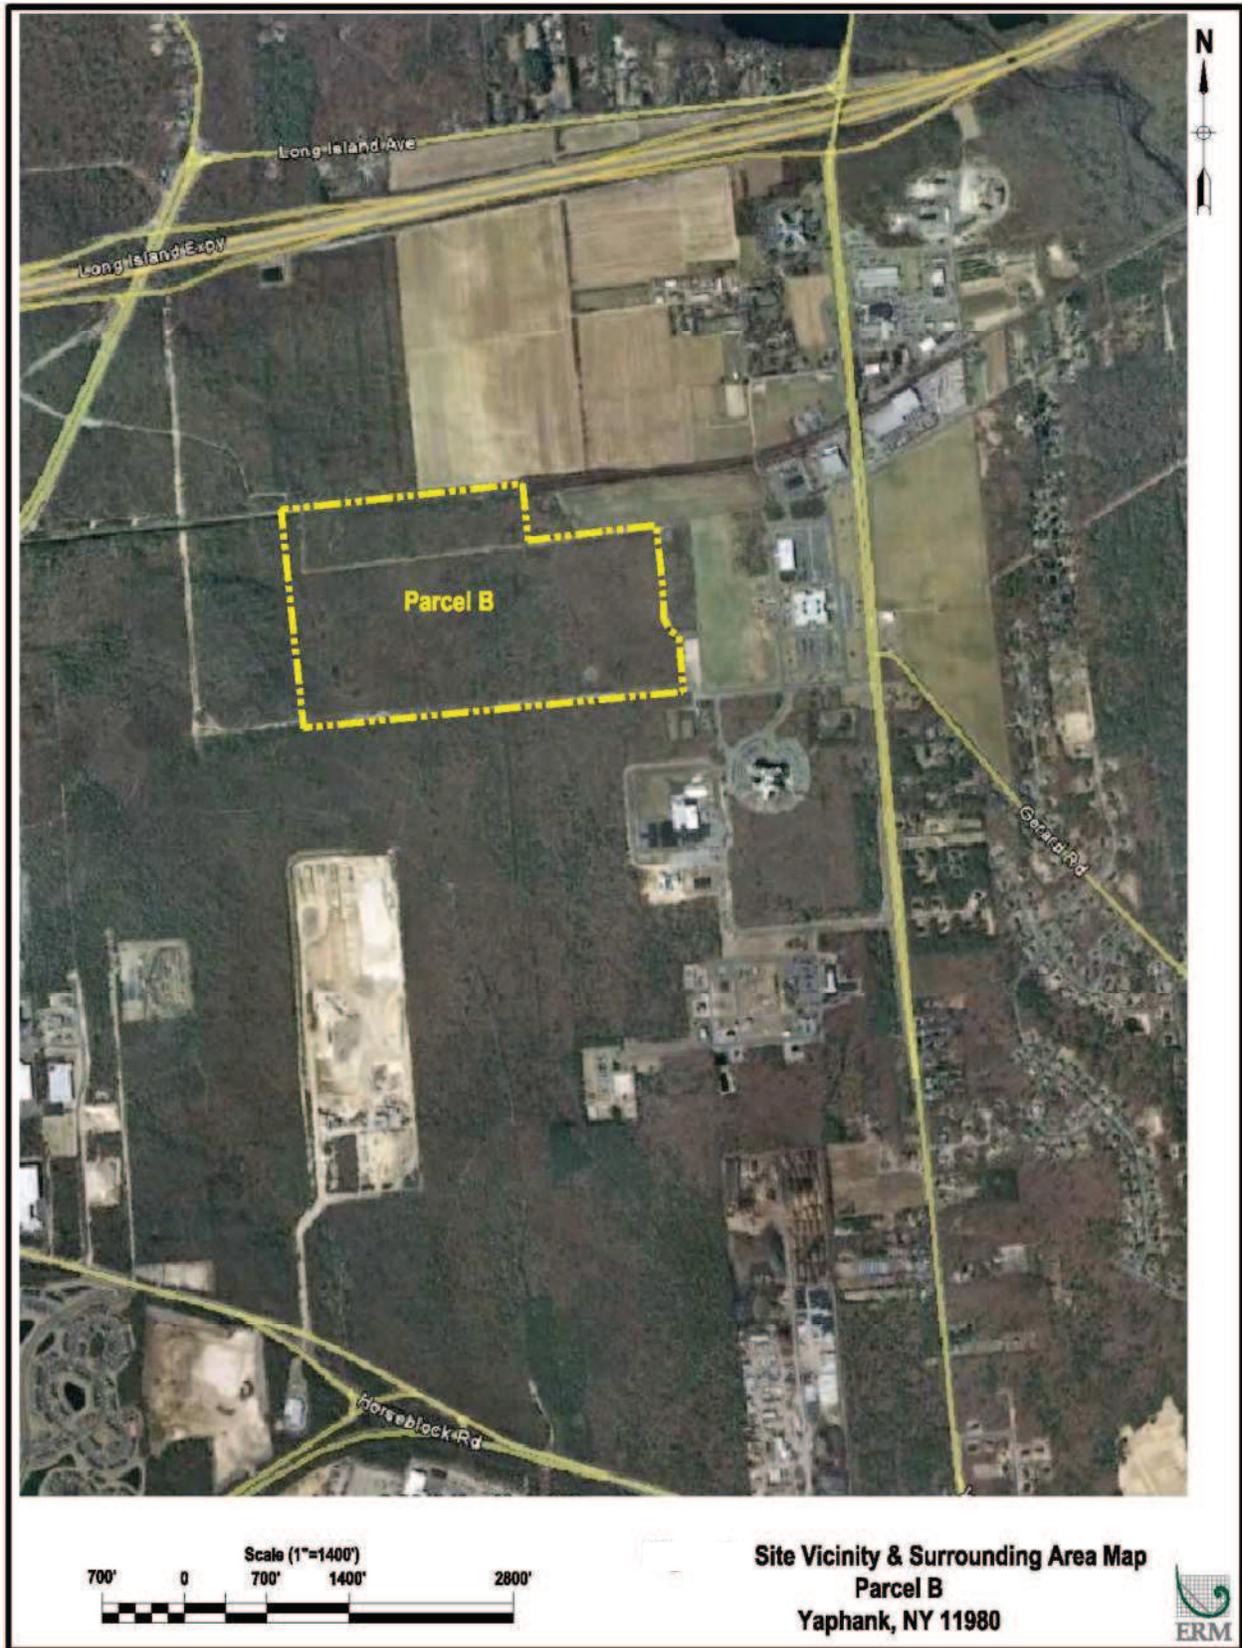
Area B is a ±123 acre rectangular Area of land is located in the Town of Brookhaven, New York, approximately 1/3-mile south of the Long Island Expressway (Interstate-495) and 1/4-mile west of Yaphank Avenue (County Road 21). The general location of Area B and the surrounding area physiographic features are shown on Figure 4-2.

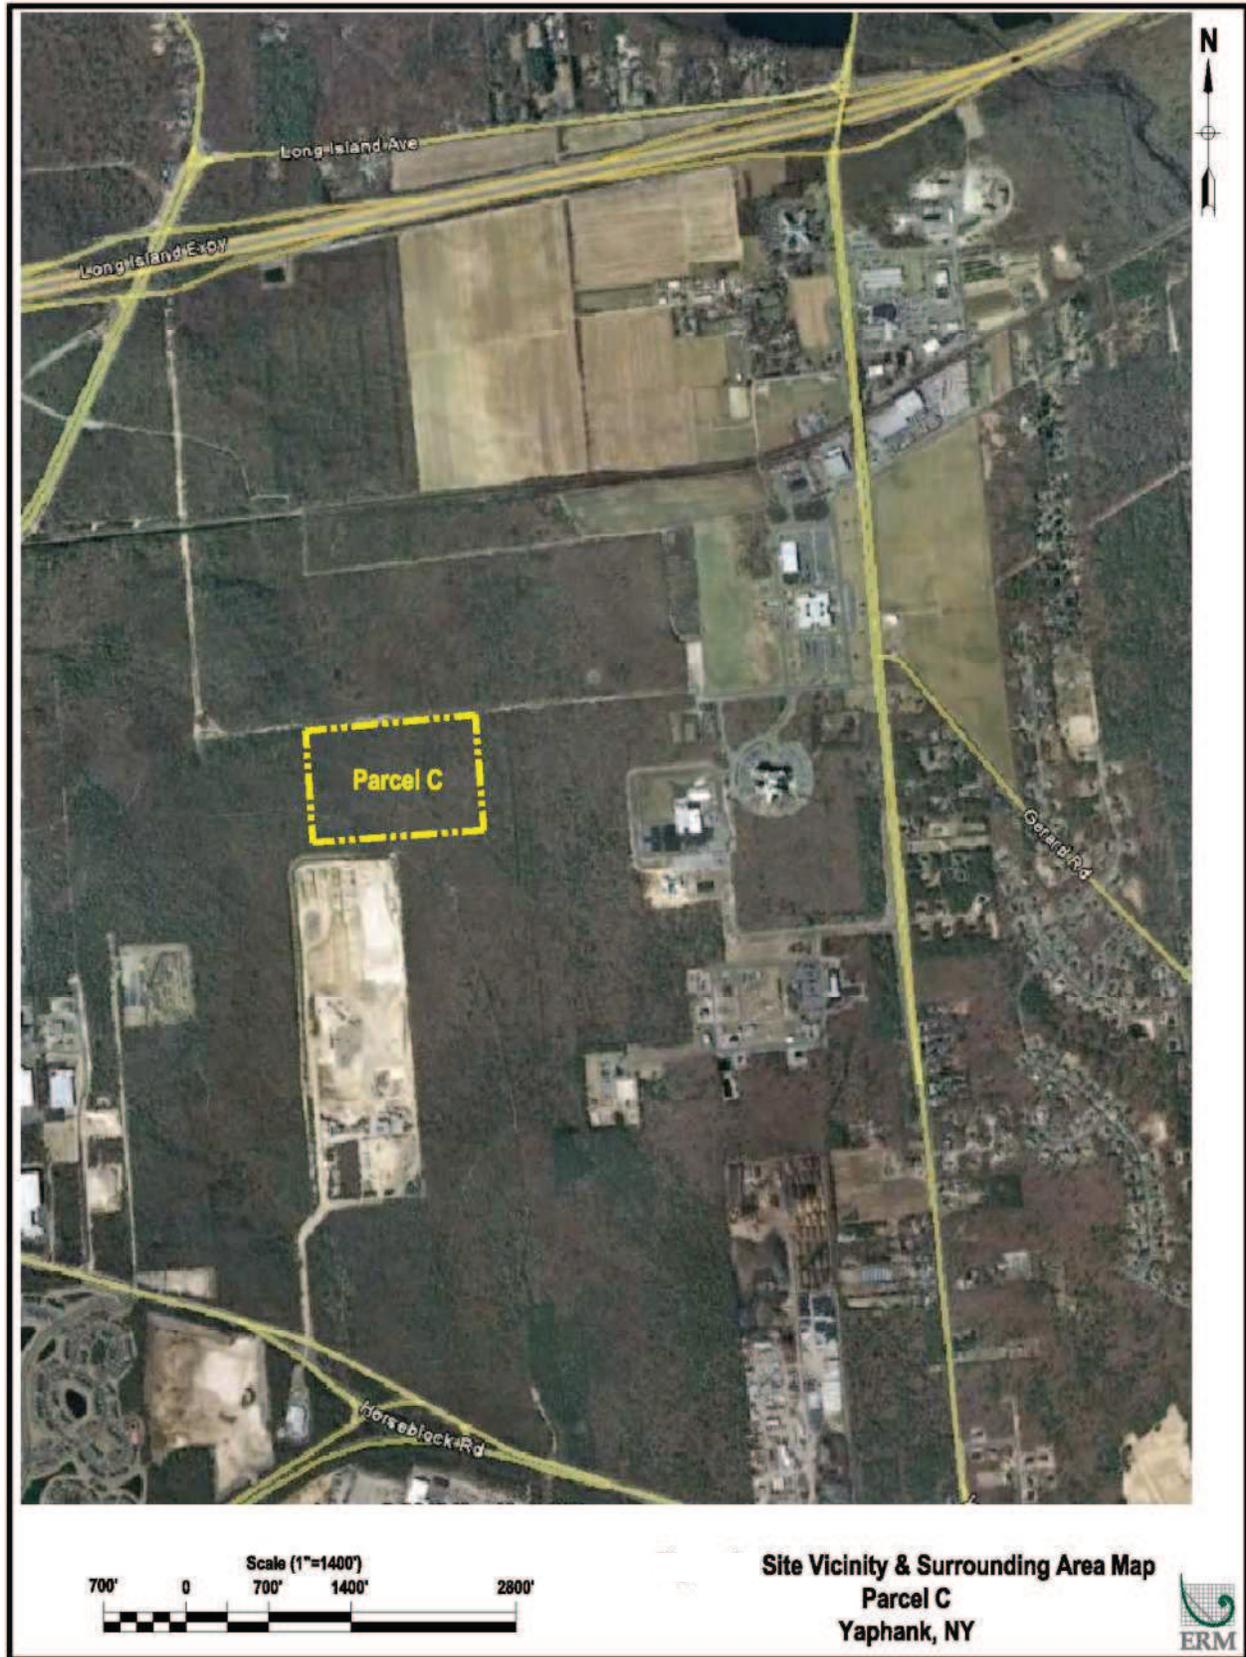
Area C is a 30± acre rectangular Area of land is located in the Town of Brookhaven, New York, approximately 0.75-mile south of the Long Island Expressway (Interstate-495) and 0.6-mile west of Yaphank Avenue (County Road 21). The general location of Area C and surrounding area physiographic features are shown on Figure 4-3.

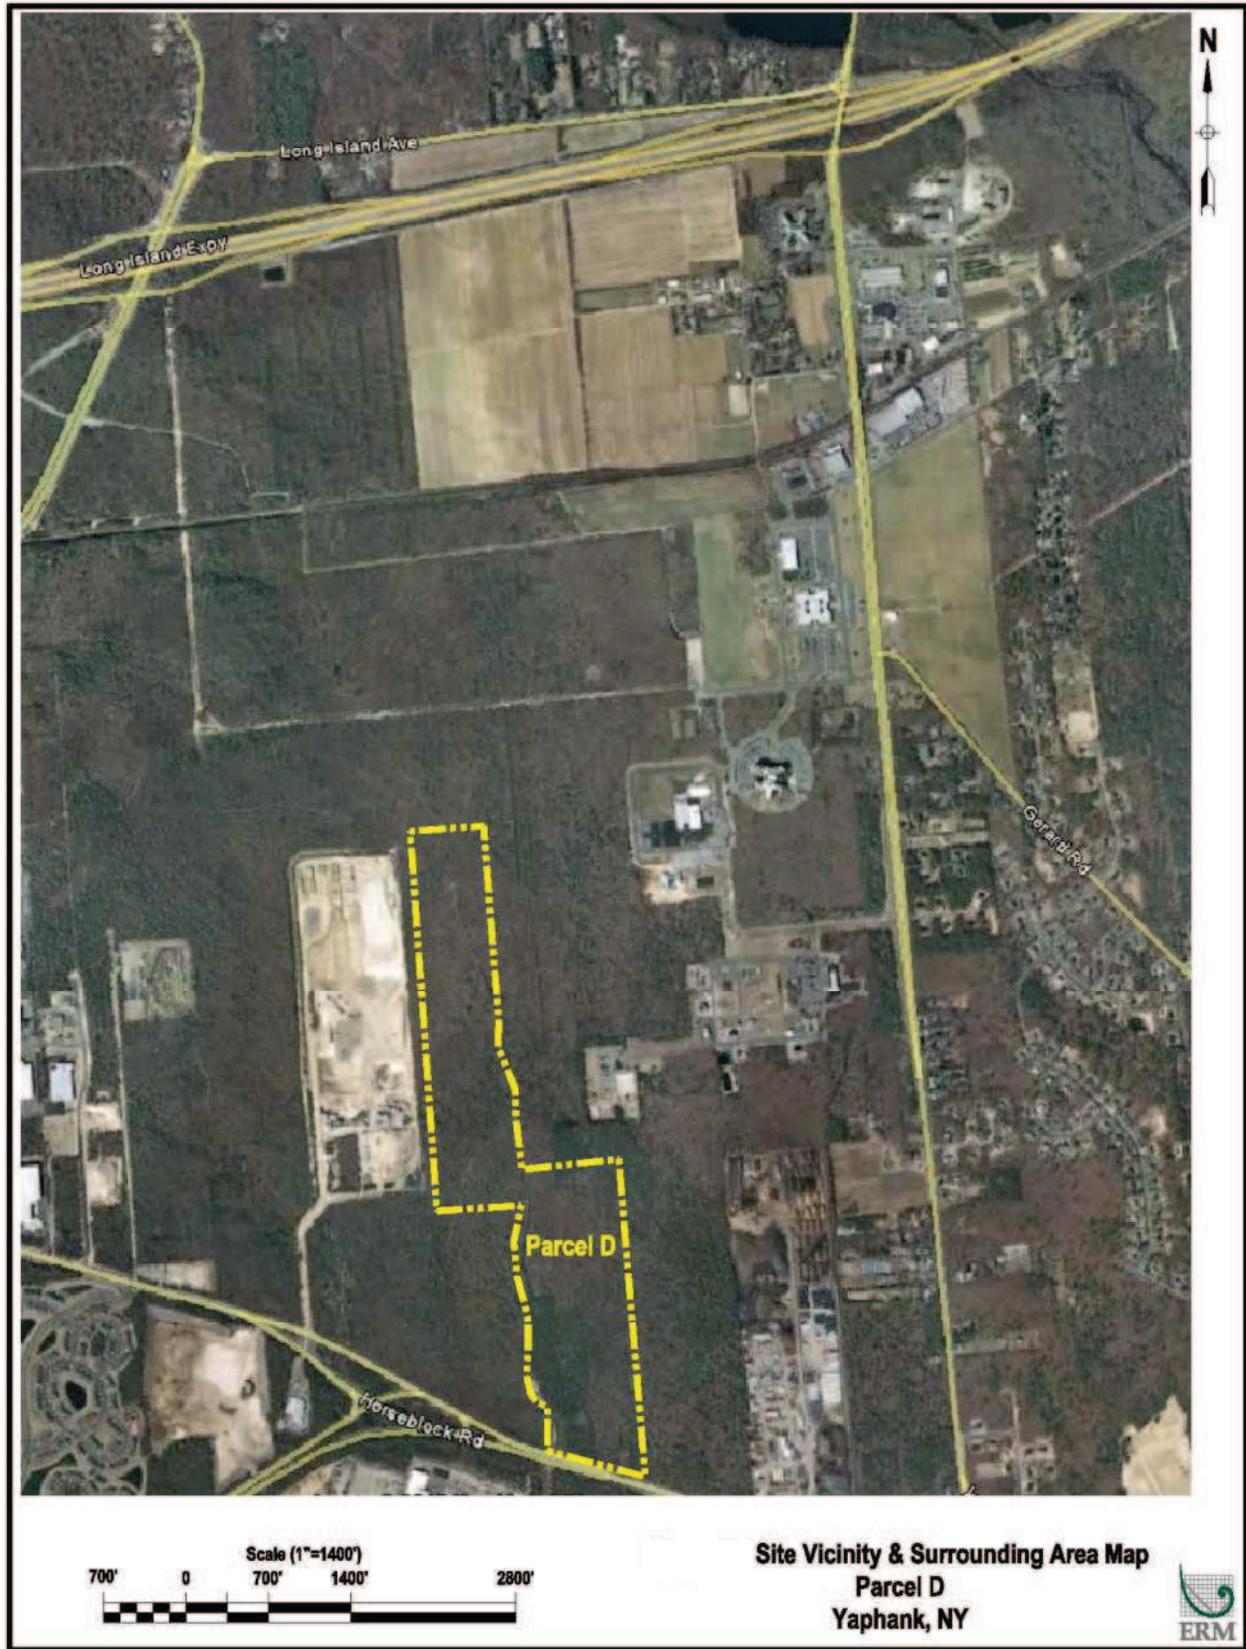
Area D is a 95± acre lateral double-rectangular Area of land is located in the Town of Brookhaven, New York, approximately 1-mile south of the Long Island Expressway (Interstate-495) and 1/2-mile west of Yaphank Avenue (County Road 21). The general location of Area D and the surrounding area physiographic features are shown on Figure 4-4.
