**UNDERGROUND
STORAGE TANK
CLOSURE REPORT**

**Suffolk County Department of Public Works
Former Gallo Duck Farm
Gazzola Drive
East Patchogue, New York 11772**

Prepared On: March 31, 2009

F&N Job No.: 0810017

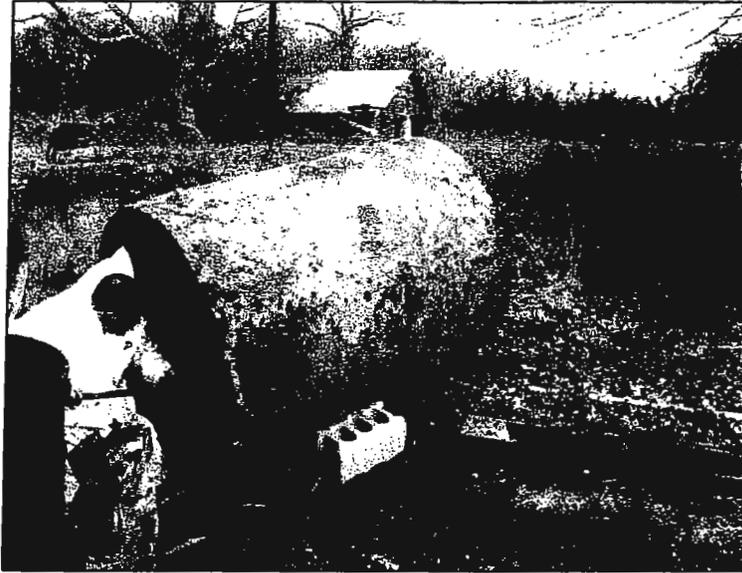
Tank 5

A 550 gallon single wall steel UST identified by the SCDHS as tank number 5 was located on the east side of a slaughterhouse on the southern portion of the property. This building is still present at the site. This UST was utilized to supply heating oil to the building. The UST excavated utilizing a backhoe to expose the tank top and to facilitate removal of residual liquid from the tank. After the UST was uncovered, a vacuum truck was utilized to pump approximately nine (9) inches (115 gallons) of residual liquid from the bottom of the UST. The UST was removed from the excavation and transported to a designated area where it would be cut and cleaned. The excavation was eight (8) feet long and seven (7) feet wide and had a total depth of six (6) feet. The UST was cut and cleaned, the tank sludge from the UST was placed in a 55 gallon drum (See Appendix A - Waste Manifests). Mr. Walter Petrule of the SCDHS and an F&N geologist inspected the UST. The UST was found to be in good condition with only slight pitting and scaling, with no observable holes: (see Appendix D – Photo Log).

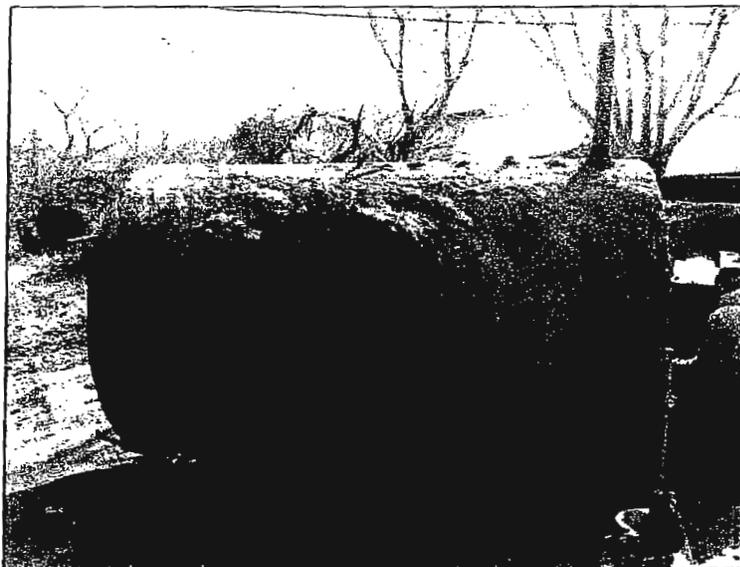
Tank 8

A 1,000 gallon single wall steel UST identified by the SCDHS as tank number was located along the west side of the property on the north side of a foundation for one (1) of the duck buildings which has previously been demolished. This UST was utilized to supply heating oil to the building. The UST excavation was performed utilizing a backhoe. After the UST was

uncovered a vacuum truck was utilized to pump six (6) inches of residual liquid, approximately 50 gallons from the bottom of the UST. The UST was removed from the excavation and transported to a designated area where it would be cut and cleaned. The excavation was twelve (12) feet long and nine (9) feet wide and had a total depth of five (5) feet. The UST was cut and cleaned, tank sludge from the UST was placed in a 55 gallon drum (See Appendix A - Waste Manifests). Mr. Walter Petrule of the SCDHS and an F&N geologist inspected the UST. The UST was sixty four (64) inches in diameter and had a length of six (6) feet. The UST was found to be in good condition with only slight pitting and scaling. There were know holes observed in the UST (see Appendix D – Photo Log).
