**UNDERGROUND
STORAGE TANK
CLOSURE REPORT**

**Suffolk County Department of Public Works
Former Gallo Duck Farm
Gazzola Drive
East Patchogue, New York 11772**

Prepared On: October 1, 2008

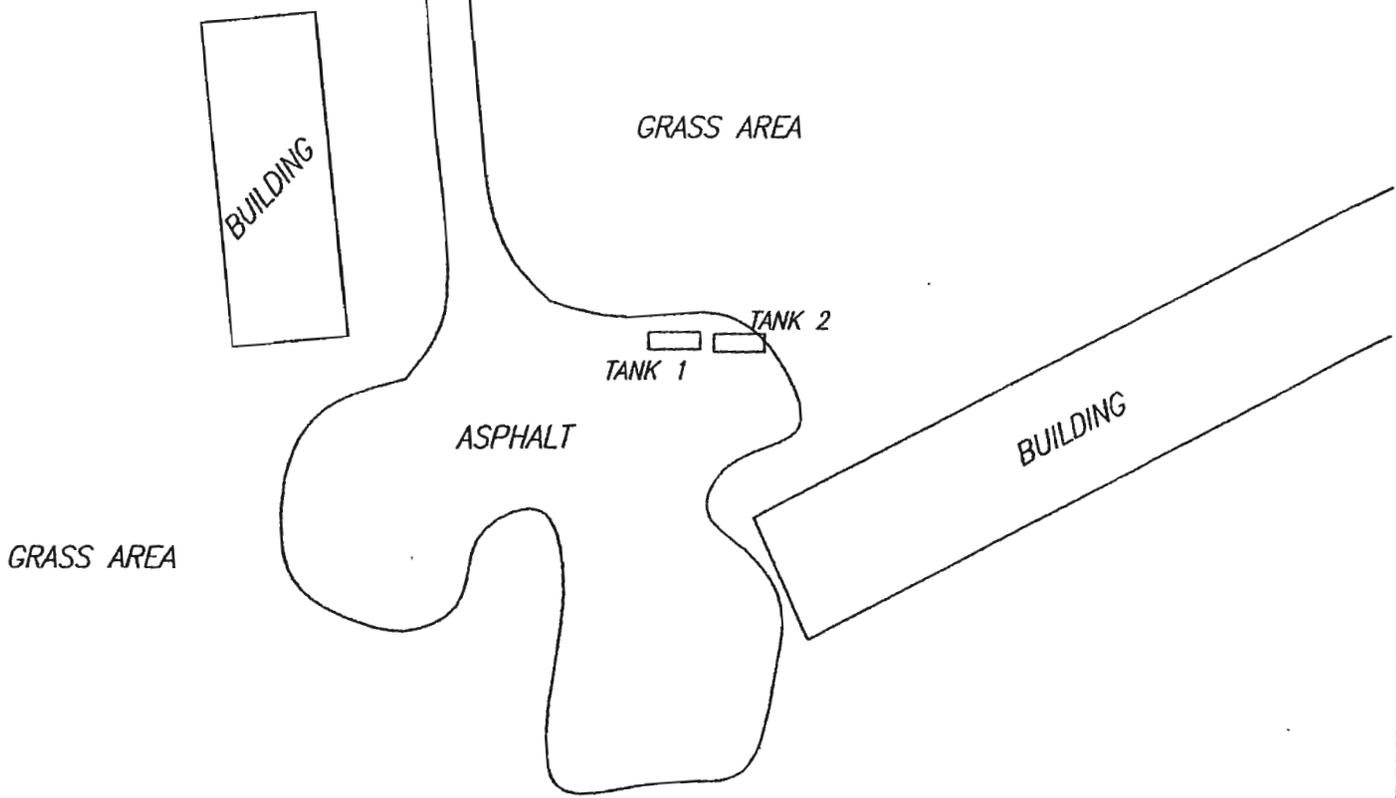
FIGURE 2
SITE PLAN

The Site is located at a property owned by the Suffolk County Parks Department, known as the Former Gallo Duck Farm. The site is located on Gazzola Drive, East Patchogue, New York. The work is being performed for the Suffolk County Department of Public Works. The USTs were separate from each other by approximately 15 feet and were therefore treated as two (2) separate removals. The USTs were located in an open area near a former maintenance garage and generator building. (See Figure 2 – Site Plan).

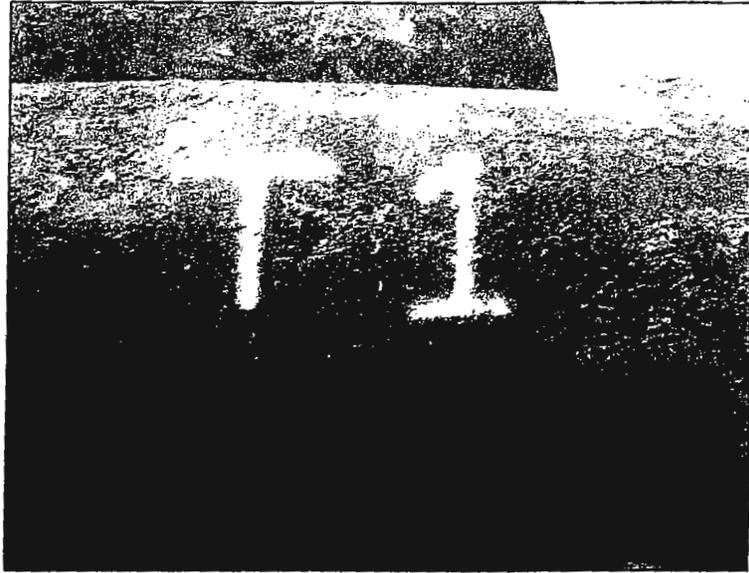
The first UST removed was designated as T-1. The excavated soil was field screened by means of visual and olfactory observations. No impacted material was encountered during the excavation and removal of the UST. Mr. Walter Petrule of the Suffolk County Department of Health Services (SCDHS) was on site during the extraction of the UST. The UST was a 550 gallon, single wall, steel tank approximately eight (8) feet long and forty (40) inches in diameter. The tank was in moderate to poor condition. There was slight pitting on the top and sides, with severe pitting and several small holes along the bottom of the UST. The UST was cut and cleaned and left onsite for inspection by the New York State Department of Environment Conservation (NYSDEC) case manager, Ms. Jennifer Pitkewicz. Ms. Pitkewicz was on site to evaluate the excavations and soil quality. As a result of there being an open spill number, Ms. Pitkewicz direction the depth of excavation be increased to a depth of approximately nine (9) feet below grade. The final excavation was approximately six (6) feet wide, ten (10) feet long and nine (9) feet deep. The UST was cut, cleaned, and secured for off-site disposal at an approved waste disposal facility (see Appendix D – Photo Log).

Tank 1

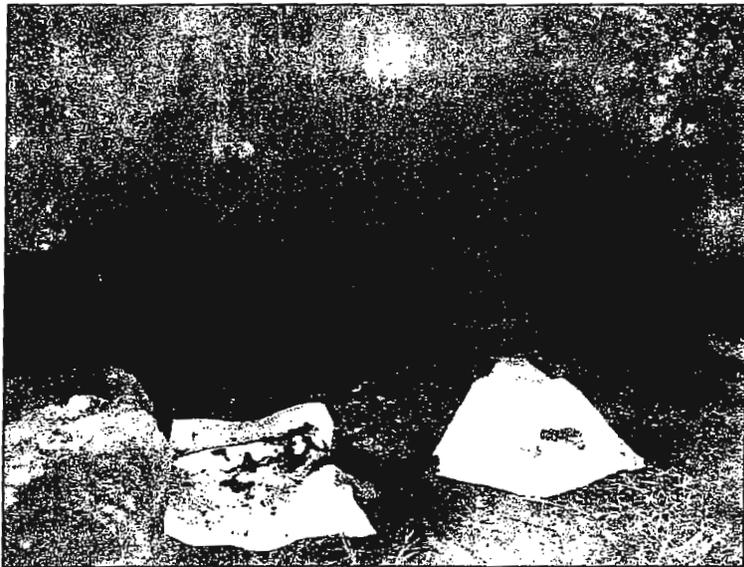
Two (2) 550-gallon, gasoline USTs were excavated and removed from the former Gallo Duck Farm. At the time of removal, Tank T-1 was found to be in poor condition with severe pitting and several holes along the bottom of the UST. Tank T-2 was in good condition with no pitting. Soil samples were collected from the side walls and bottom of each UST each excavation. At the time the soil samples were collected, olfactory evidence of impacted soil was present at the base of the excavation from Tank

Tank 1 Holes

- No additional work be performed at the site relating to the two (2) USTs
- A copy of this report be forwarded to the SCDHS for their records
- A copy of this report be forwarded to the NYSDEC, with a request that spill number 8-01293 be closed and a "No Further Action" Letter be issued to the site

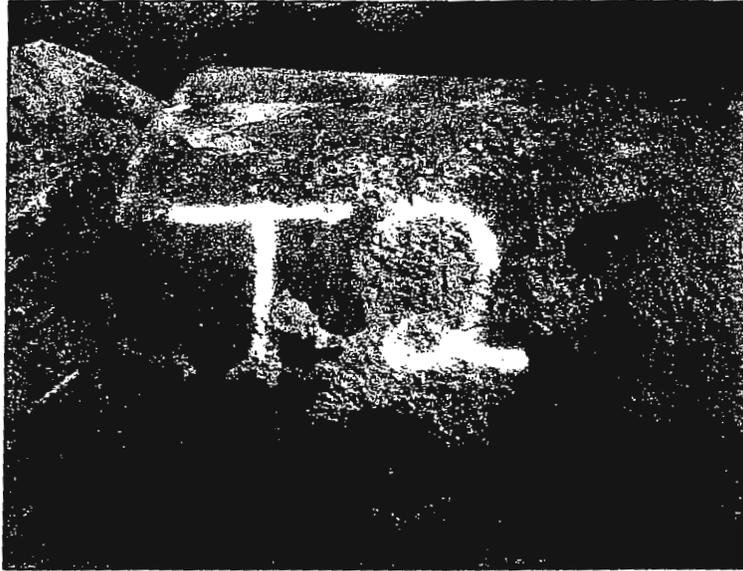
The second UST removed was designated as T-2. Excavated soil was field screened by means of visual and olfactory observations. No impacted material was encountered during the excavation and removal of the UST. Mr. Petrule was onsite to evaluate the excavation and condition of the UST. The removed UST was visually inspected by F&N Personnel and by Mr. Petrule at the time of removal. The UST was a 550 gallon single wall steel tank approximately six (6) long and forty-eight (48) inches in diameter. The UST was found to be in good condition with little to no evidence of pitting. The excavation was approximately ten (10) feet long by six (6) feet wide and five (5) feet deep. The UST was cut and cleaned, and secured for off-site disposal at an approved waste disposal facility pending inspection by Ms. Pitkewicz. Upon approval from Ms. Pitkewicz the UST was disposed of off site, soil sampling was performed per her directive.

Tank 2
